# DDASaccident456

# DDAS Accident Report

INVESTIGATION REPORT INTO MINE ACCIDENT WHICH OCCURRED ON 30 JULY 2002  
AT CMT MINEFIELD, PAILIN

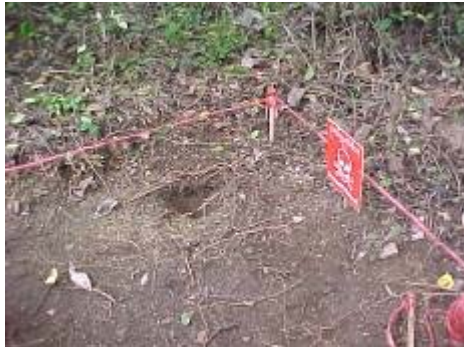
[The accident site]

The [Demining group] CMT Team had just commenced clearance operations at the hill top Pagoda site the same morning as the accident. Part of the team was clearing an area close to a stream bed at the bottom of the hill which has a lot of rocks and other vegetation. The immediate area above the site is very steep with loose metal.

Yes. A bulldozer has been used to level the top of the hill and has pushed gravel and stones down the sides of the hill. It is also an old Pagoda site so there is a lot of rubble around. A lot of bush exists at the base of the hill around the stream which also makes it very difficult to demine.

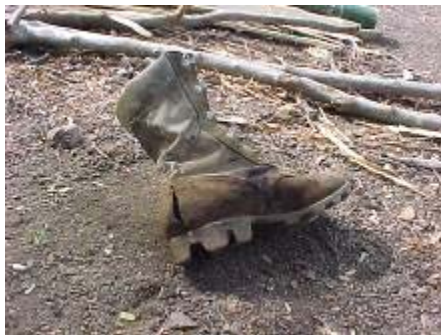
[The victim's boot.]

The deminer suffered a blast injury to his left foot that later required amputation above the ankle.
